INDOOR AIR QUALITY ASSESSMENT

**Muddy Brook Regional Elementary School
318 Monument Valley Rd
Great Barrington, Massachusetts**

Prepared by:
Massachusetts Department of Public Health
Center for Environmental Health
Emergency Response/Indoor Air Quality Program
May 2006

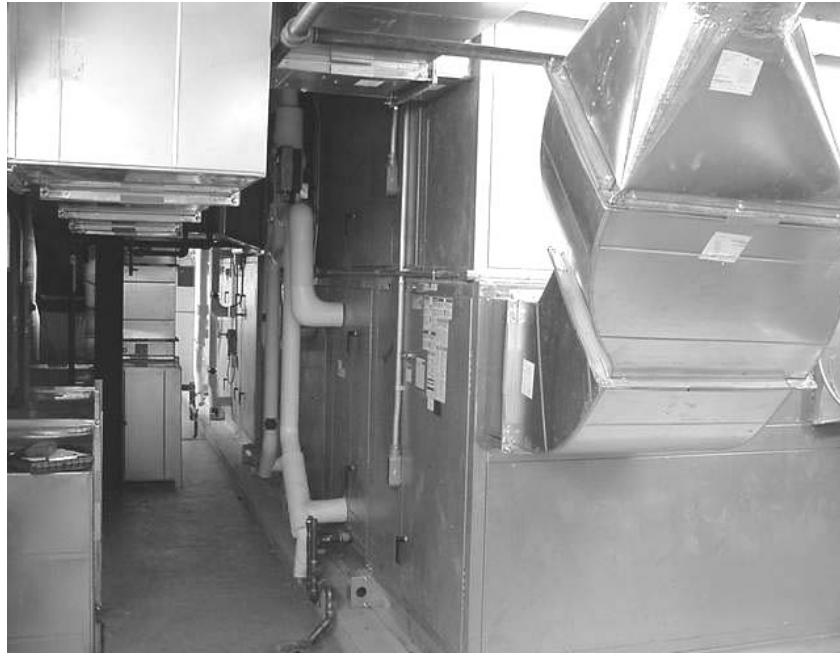
Picture 1

A heating, ventilation and air conditioning (HVAC) system provides ventilation to rooms throughout the school. Fresh air is provided by air handling units (AHUs) (Picture 1). These AHUs are connected to ducts that supply fresh air to rooms through ceiling mounted air diffusers. By design, air diffusers are equipped with fixed louvers,

AHUs

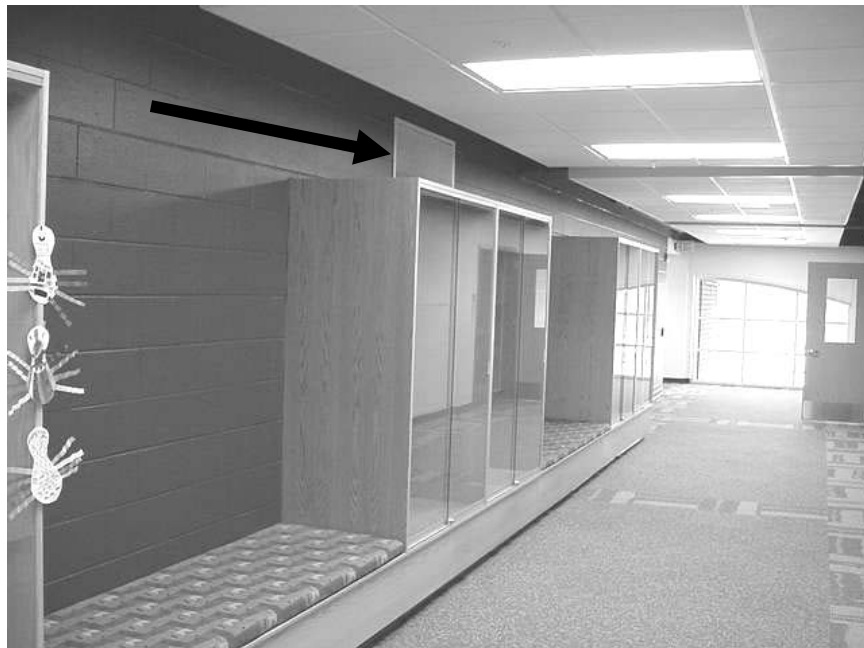
Picture 2

Of note was a motorized exhaust vent located above a hallway display case, opposite the elevators (Picture 2). As is typical of this design, ductwork connects this

Of note were two areas that had distinctive odors. The elevator car and third floor hallway had a hydraulic fluid odor, which is an oily, irritating scent. Of note is the previously discussed return air vent in the hallway, which is located opposite the third floor elevator doors. The return vent appeared to be drawing air rapidly at the time of

assessment. This vent may have a significant role in the noted hydraulic fluid odor. The vent likely draws odors up the elevator shaft.

Exhaust Vent in the Hallway opposite the Elevators

1. Continue to implement previous MDPH recommendations concerning water damage ([Appendix B](#)).
2. Examine the feasibility of installing ductwork to connect third floor rooms with passive vents to the AHUs to reduce hallway depressurization.
3. Examine the VAV box servicing rooms 210, 212 and 214 for proper function. Adjust the VAV box to introduce more fresh air.
4. Repair hydraulic fluid leak causing odor in the elevator shaft.
5. Remove rubberized mats from the foyer and allow to air out in an area outside the school. Contact the manufacturer for information on the most appropriate manner to remove odor from these mats, which may include cleaning with mats with soap and water, then thoroughly drying.

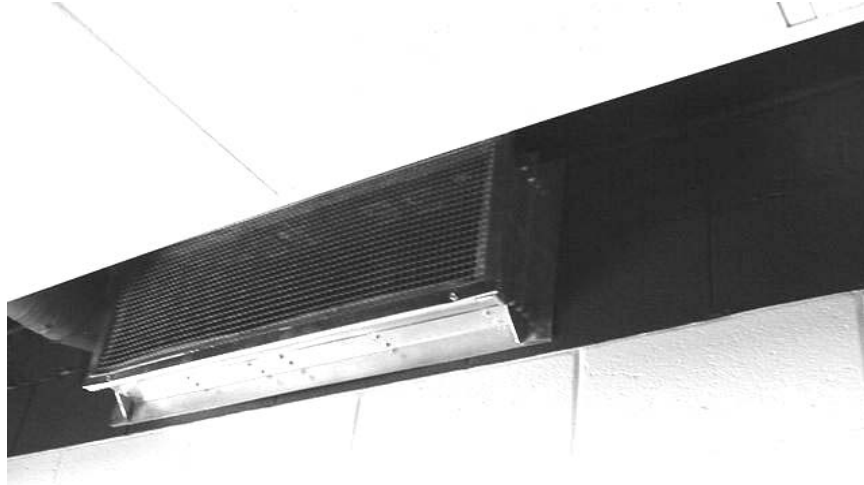
Picture 3

exhaust vent to the AHU. Rooms on the elevator side of the hallway have passive vents (Picture 3) that allow air to pass into the hallways and be drawn into the hallway vent; these rooms do not have mechanical exhaust vents within the room. The hallway vent does not provide adequate draw of air from classrooms with passive vents. The hallway exhaust vent does, however, draw air from the nearby elevator shaft.

Passive Vents in Hallway opposite the Return Vent In Picture 2

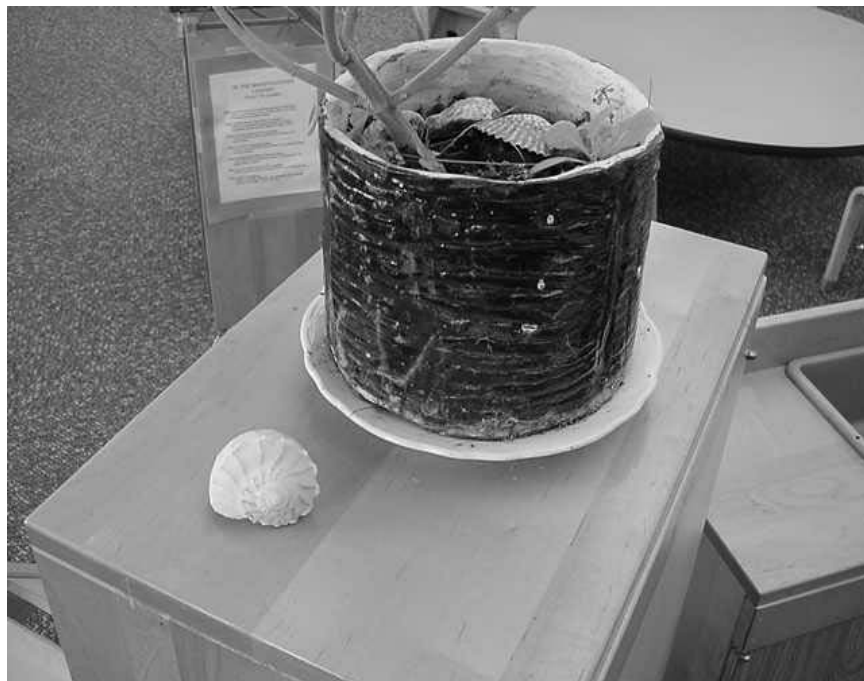
Picture 4

Plants were observed in several areas (Picture 4 and 5). In one classroom, a large plant was located on top of the carpet (Picture 5). Plants should have drip pans to prevent wetting and subsequent mold colonization. Plants, soil and drip pans can serve as sources of mold growth, and thus should be properly maintained. Plants should not be placed on carpeting or porous materials, as overflow in drip pans can result in mold growth in such materials. Plants should also be located away from ventilation sources to prevent aerosolization of dirt, pollen or mold.

Plants in Classroom

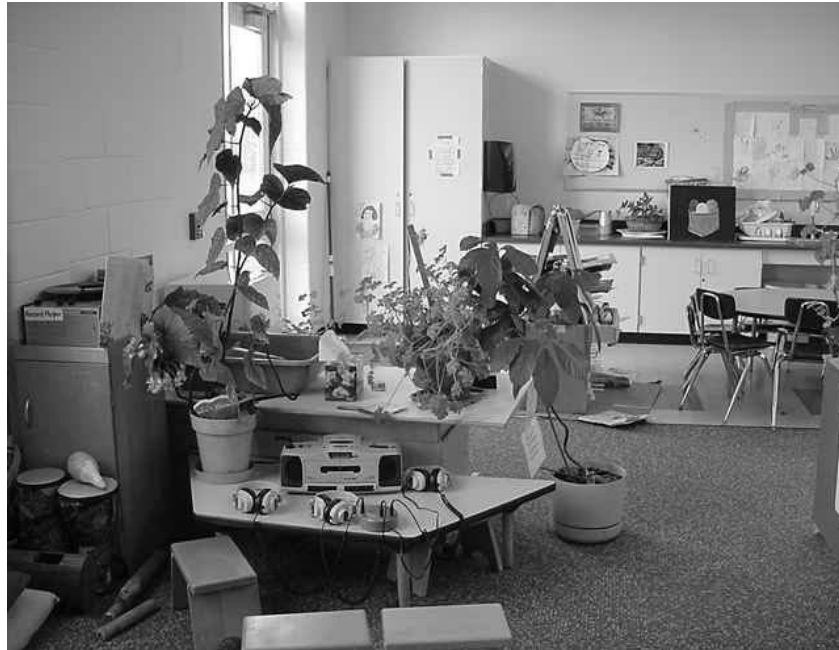
Picture 5

Plants in Classroom

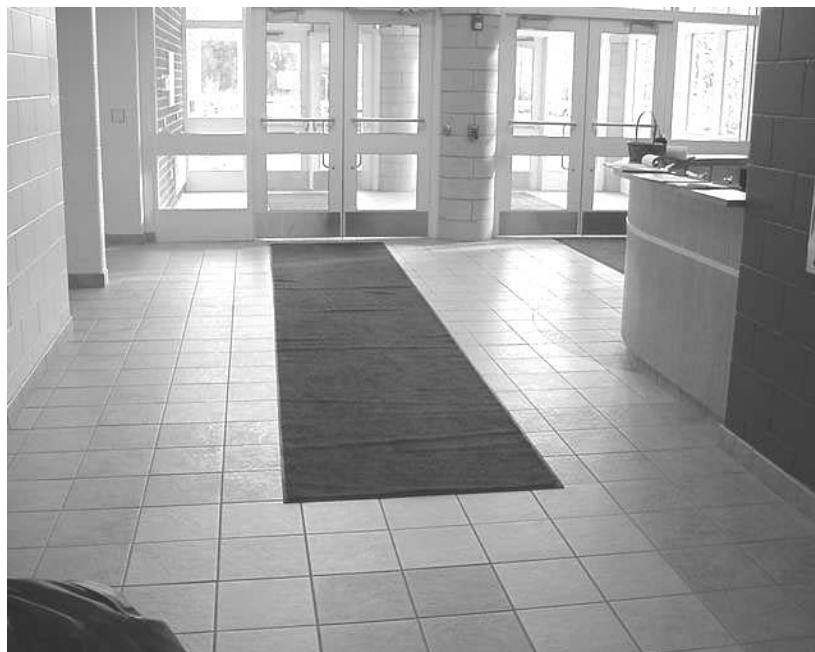
Picture 6

A strong, rubber/plastic odor was detected in the front foyer of the MBRES. The source of this odor appears to be floor mats on the floor of the foyer (Picture 6). The floor mats appear to consist of a plasticized rubber-like material. The front foyer is a metal/glass structure (Picture 7) that does not contain any mechanical ventilation. As the foyer warms through solar radiation, the temperature increases, which then accelerates off-gassing of odor from these mats. A return vent for the ventilation system is located above the reception desk. The vent will tend to draw the mat odor into the building when the foyer doors are open. The mat odor is an acrid, unpleasant odor which can be irritating to the nose and throat for some individuals.

Foyer Carpet

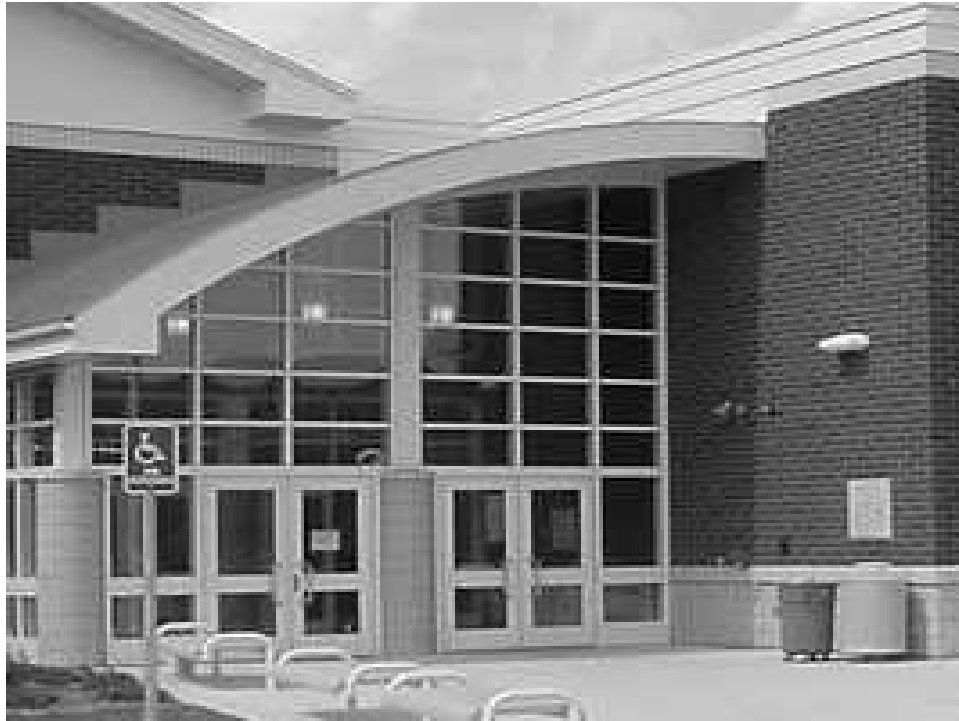
Picture 7

Front Foyer, Exterior Shot
